# CANYON CREEK PARKING LOT LIGHT REWORK PROJECT

Overview of the rework of the Canyon Creek Parking Lot  
Light project completed August 15th, 2020.

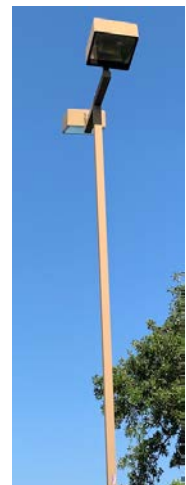
Figure 1 - Older HID Shoebox Fixture

The shoebox fixtures originally housed HID bulbs which are an old technology and is being phased out. See Table 1 – Efficiency Comparison of Illumination Technologies.

As a temporary measure, the association had installed “LED corn cob” style bulbs as a cost-effective transition. This decision was made at a time when Integrated LED fixture costs were still high, but we wanted to consider an alternative to HID bulbs.

Moving to a more efficient device involved completely replacing the obsolete “shoebox” style fixture.

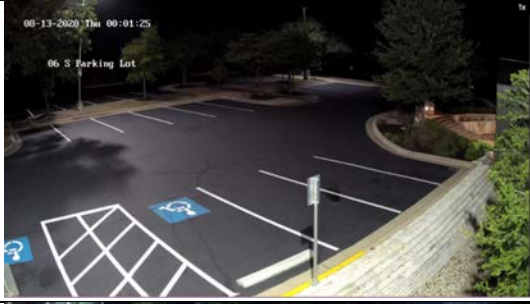
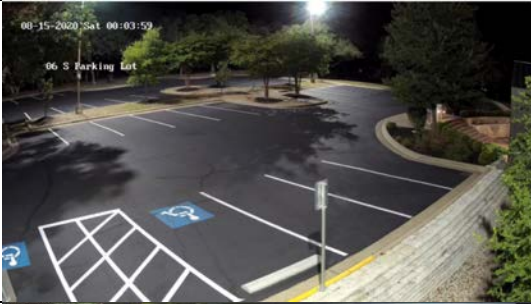
Before new lights were installed	After new lights were installed. Note light at the far ends of views and notice contrast.
Camera #6: Looking from south

- Camera #6: Parking lot beyond island is now visible.
- Camera #7: Substantially more light across parking lot. Foreground now appears to be yellow by comparison as more light in background is available.
- Camera #8: Improved image contrast – less of image is illuminate through ambient and camera infrared technology.
- Camera #4: Improved image contrast – less of image is illuminate through ambient and camera infrared technology. View of sidewalk down toward basketball court is more visible. Direct view on west side of parking lot.
